Boundary Layer Transition Results From STS-114

Scott A. Berry*, Thomas J. Horvath* NASA Langley Research Center, Hampton, VA, 23681

Abstract

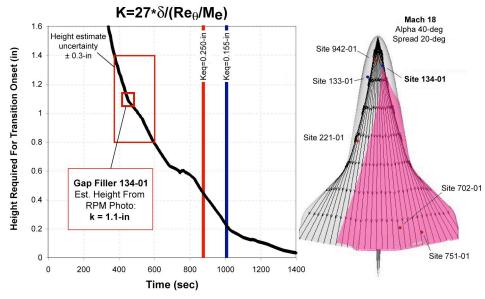
Figure 6. BLT assessment for gap filler 134-01

For gap filler 134-01 (shown in Fig. 6), the location was found to be just within the portside attachment line (indicated by the outboard limit of the streamlines shown) such that the downstream influence of transition would be felt asymmetrically over a large portion of the windward surface and the wing leading edge on the port side. Most importantly, the estimated height of this gap filler protrusion exceeded the previous worst-case protrusion (which was based on a post-flight measurement only) by nearly a factor of two. Based on the output from the BLT Tool, this height and location corresponds to a very early transition time, roughly 450s (~Mach 25) with an uncertainty band (based on the uncertainty in the height estimation, ±0.3-in, from the RPM photos) of roughly ±75s. As mentioned previously, transition this early is outside the accepted limit for the tool, requiring extrapolation beyond both the computational and calibration ranges of the tool. The impact of this will be further discussed in a subsequent section. Note that the wedge tool shows that gap filler 134-01 will influence damage sites 702-01 and 751-01, and the analysis of these two sites had to account for these early transition onset times in the event that the gap fillers were left as is (eventually the decision was made to remove the gap fillers, also to be discussed subsequently).

Based upon the cascade of uncertainties associated with the suite of analytic tools (BLT, thermal, and structural, etc.) for both the windward acreage tiles and the wing leading edge RCC panels, the decision was made by the MMT to utilize the ISS robotic arm to locate an astronaut near the gap fillers for removal during extravehicular activity (EVA) #3. The decision to attempt a repair was made easier by a well thought out operational plan that provided assurance that any safety concerns were minimized. Prior planning and forethought on how to secure an astronaut to the boom and the

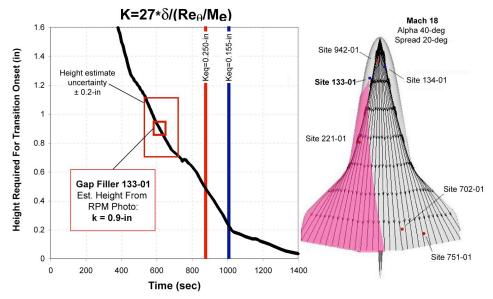
Figure 7. BLT assessment for gap filler 133-01

For gap filler 133-01 (shown in Fig. 7), the location was found to be just outside the starboard attachment line, and that based on the conservative estimate of 10-deg of turbulent spreading the downstream impact of transition would be felt asymmetrically over roughly the other half of the windward surface and the wing leading edge on the starboard side. Further analysis of turbulent spreading lead to the conclusion that if the wedge half-angle was less than 7.5-deg (which is considered nominal for flight) then the turbulent wedge would likely not spread back within the attachment line, thereby having no effect on the windward surface or the wing leading edge. However, this gap filler protrusion was also estimated to be nearly as large as 134-01, again nearly double the previous worst-case protrusion. The initial output from the BLT Tool indicates that this height and location also corresponds to a very early transition time, roughly 600s (Mach 24) with an uncertainty based on the height estimation uncertainty only of roughly ±75s. This transition time is again outside the accepted range for the tool. Note that the wedge tool results shows that gap filler 133-01 will influence damage sites 221-01, and the subsequent analysis had to account for potential for an early transition onset time.

As mentioned previously, both gap fillers were scanned with the OBSS in hopes of reducing both the height and the estimation uncertainty. Unfortunately, the gap filler scan results were inconclusive, so the initial prediction of onset time could not be updated. An assessment of the reliability of these early transition predictions was conducted with a critical eye towards the degree of extrapolation. The existing high Mach number flight data used to calibrate the tool were reexamined in hopes of identifying any method to quantify the level of uncertainty with the present results being so far beyond the tool's range. An adjustment to the accepted calibration constant, based on the notion that the original STS-73 data had been misinterpreted provided a means to alter the predicted transition onset times to 745s (~Mach 22) and 790 (~Mach 21) for 134-01 and 133-01, respectively (however with still a large uncertainty band ±Mach 2.5). The previous evaluation of STS-73 was based on the gap filler height measured on the runway, which was bent over such that the total height above the surface was 0.6-in, while when straightened the gap filler was 1.4-in high. Using the unbent height along with the transition onset time for that flight provided an alternate calibration curve coefficient (C=50), which resulted in the adjustment to the predicted transition time. Also, independent experts were consulted during the mission for outside opinions on these early transition time predictions from the BLT Tool. Unfortunately, all independent assessments came back with roughly the same order-of-magnitude estimate for transition onset, providing a sanity check but little relief to the perceived conservatism of the BLT Tool. A flight history review reveals that many gap fillers have been noted as bent over on the runway based on the post-flight inspections. A spirited and healthy debate occurred over whether gap fillers this large might bend over or burn away early in the trajectory, thus reducing the protrusion height, and the transition Mach number, down towards the historical limit. Unfortunately, a structural assessment of the gap filler material response under aeroheating loads was not available during the mission to support or dismiss this speculation.

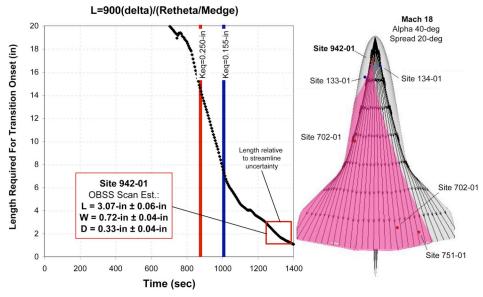
Figure 8a. BLT assessment for cavity site 942-01 based on length

The BLT Team also investigated damage site 942-01 during the mission, due its relatively large size and far-forward location. A comparison of the lengths and widths listed for each cavity identified in Fig. 5 distinguishes 942-01 as one of the larger cavities. The location on the nose landing gear door, which was just inside of the starboard attachment line (as identified in the turbulent wedge plot shown in Fig. 8a) provided the potential to affect a large portion of the windward surface. The initial RPM estimate, listed in Table 1, provided length (3.2 in) and width (0.8 in) only. Based on the initial length estimate only, a transition time of 1225s was predicted. When the new OBSS scan updates became available and the length was reduced to 3.07 in, the transition onset time prediction was modified to 1240s. Also, OBSS provides the additional dimension not previously available, the depth. Based on the depth of 0.33 in, a predicted transition onset time of 1245s was obtained. Thus, if the gap fillers are removed, the predicted transition onset time would be relatively close to the nominal transition times for this vehicle (~Mach 8) based on the last damage site (known about during the mission) near the nose, site 942-01. Note that based on the BLT Tool output for 942-01, the length or depth required to predict transition onset near Mach 18 (the red K_{EQ} line) is approximately 14 and 1.6 inches, respectively.

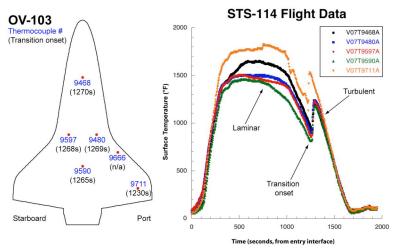
Fig. 11 Thermocouple locations for OV-103 and transition onset times for STS-114

Port side thermocouple (9711) showed the earliest transition onset time of 1230s. The central thermocouples showed a rapid movement of transition from the back to the front of 1265s to 1270s, respectively. It is interesting to note that if the entry imaging aircraft had been in position for the landing at Edwards, then it is likely one of the IR systems would have captured the transition process. Clear evidence of cause and effect and confirmation of the turbulent spreading angle would have been useful information for this post-flight assessment of STS-114.

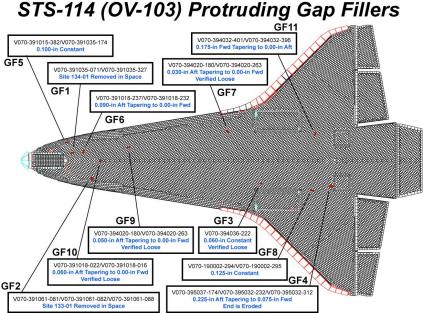
Figure 12. Protruding gap fillers on STS-114

The post-flight runway TPS inspection team at Edwards found nine additional gap fillers protruding, as noted in Fig. 12. These nine gap fillers had not been previously identified in orbit during the RPM photographic analysis. So the obvious question arises, why were these gap fillers not identified? Were the additional gap fillers too small to be noticed during the RPM process, or did they in fact protrude during

entry or upon landing? Only three of the gap fillers identified protruding on the runway were noted as potentially being during the high heating portion of the trajectory due to the resulting flow pattern and burn marks around the trip. those three, only two have been since confirmed as protruding prior to entry from a more thorough review of the RPM photos. These two were small enough, both protruding 0.1-in or less, that they were missed during the mission.

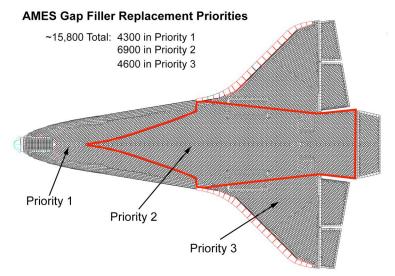
Fig. 14 Gap filler replacement priority

On the vehicle processing side, a gap filler assessment group was established to determine the root causes for the gap filler protrusions during STS-114 in order to reduce the likelihood of reoccurrence during up-coming missions. As mentioned earlier, sidewall bonding was identified as a significant issue as the adhesive material that is smeared closer to the surface will be exposed to higher temperatures, thereby reducing long-term strength of bond. Pull tests on a random selection of gap fillers on the vehicles revealed this to be an issue of concern and that many of the gap fillers in place may be of questionable capacity. Therefore, the decision was made by the Space Shuttle Program to replace all gap fillers on the vehicles (a major undertaking), using an improved installation process and new pull test standard, as soon as possible to reduce likelihood of future protrusions. Due to the shear number of gap fillers to be replaced on each vehicle (roughly 15,800 as shown in Fig. 14), the lower surface was broken up into priority zones. Gap fillers within the Priority 1 zone were required to be replaced before the next flight, as this area had the biggest influence on the wing leading edge, both from a heating perspective as well as a debris source (gap

filler liberation and subsequent impact on the wing leading edge). The remaining zones were to be completed as soon as possible, but if not done prior to launch the program recognizes that additional EVA's may be required as risk mitigation.
